### Inspection Report

#### Minerals Regulatory Program

**Mine Name:** Ziegler Chemical and Mineral Operations  
**Operator Name:** Ziegler Chemical and Mineral

**Permit number:** M0470013  
**Inspection Date:** October 31, 2006  
**Time:** 9:20-10:45 AM

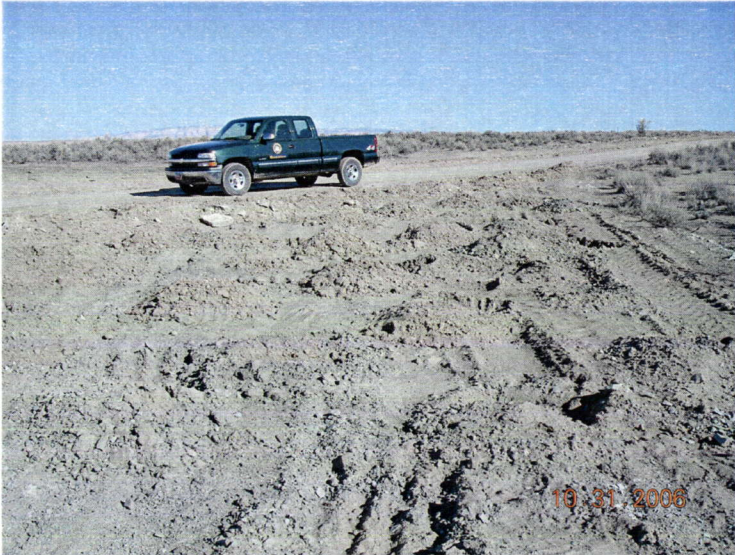
The operator has completed most reclamation at the Cowboy Mine. The access road was gouged (Photo 1), and facilities have been reclaimed except the building shown in Photo 2. Surface preparation has not been done except on the access road, and the operator has not yet seeded any of the site.

The gouging that was done on the access road does not cover the entire area. The gouged areas look very nice, but there are spaces between the gouges where it is unlikely anything will grow. The operator should consider re-preparing the surface on the access road. In the future, surface preparation should cover essentially the entire area that will be seeded.

**Photo 1. The reclaimed access road is in the foreground. Note the roughening.**

Although I prefer gouging as a roughening technique, it may be more economical to rip flatter areas.

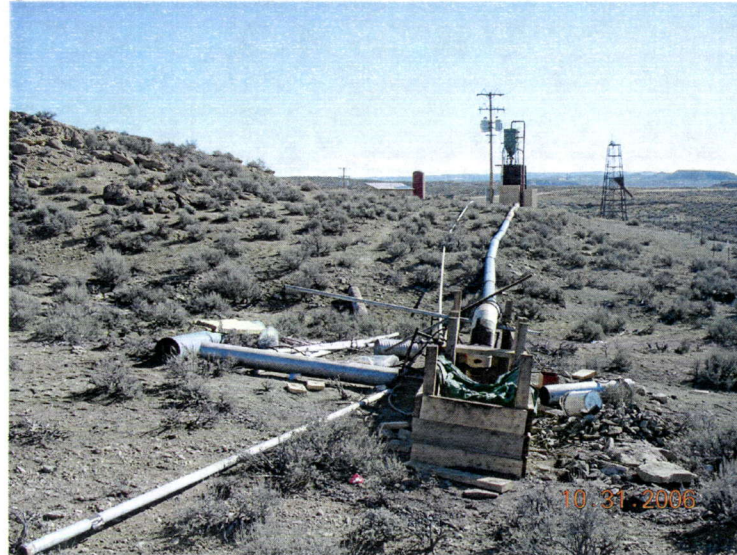
The operator had planned to do exploration drilling at the mine on the Cowboy South Vein nearest SR 45 but decided not to pursue this plan. Instead, a previously-approved shaft is being dug on the Cowboy North Vein to the northwest of the existing facilities (Photos 3-4). Excavation is being done with hand tools—chipping hammers, shovels, buckets, etc.

**Photo 3. New shaft of the Cowboy North Vein. Note the wood collar. Excavation is being done by hand.**

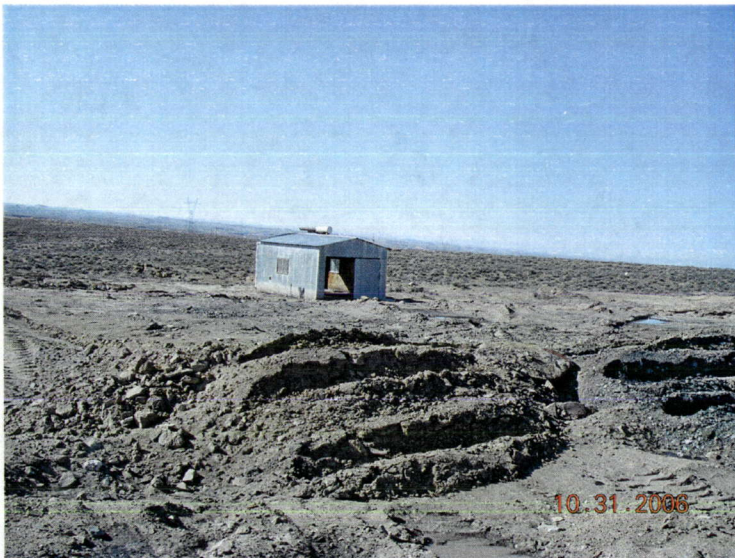
**Photo 2. The Cowboy Mine site. Reclamation has been completed except for removal of this building, final grading, surface preparation, and seeding.**

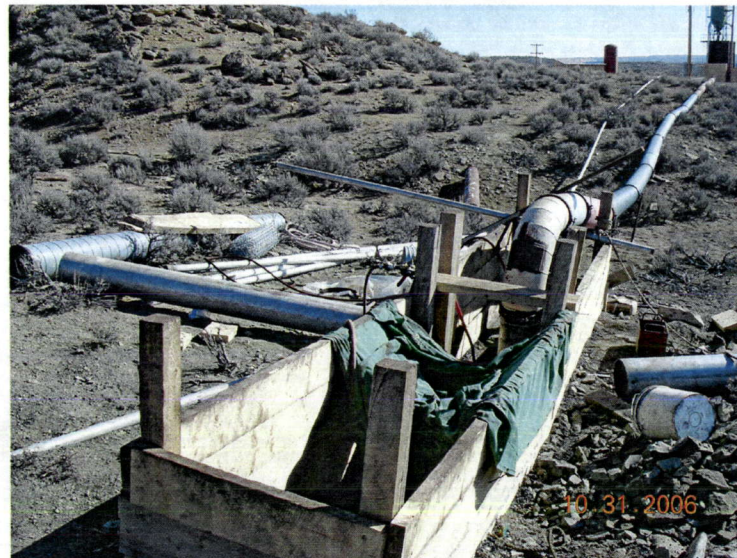
**Photo 4. Another view of the shaft on the Cowboy North Vein.**
